Flood Control Project Maintenance
2012 Structure Summary Report
Overall Unit and Item Ratings

Reclamation District No. 2063 Pumping Plant (Nelson Drain)

Flood Control Project Maintenance**Unit Cover Sheet****2012 Pumping Plant Inspection Results****Reclamation District No. 2063 Crows Landing**

Levee Inspection Report By Mile - Structure 2012

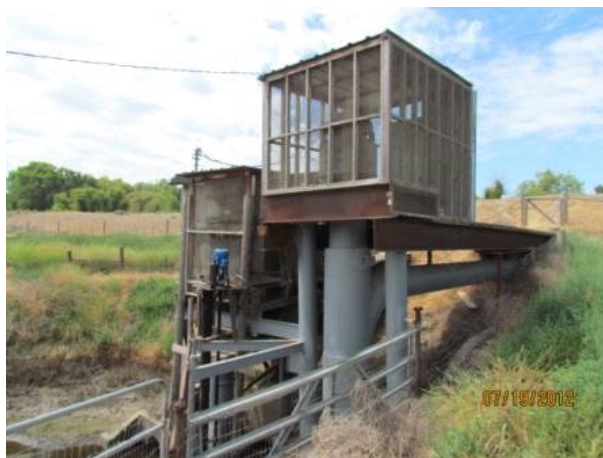
Levee Mile Report Line	4
Start Levee Mile	
End Levee Mile	
Location	
Category	Pump Stations
Item	Plant Building

LMR No.	Levee Mile		Category	Item	Location *	Rating **	Action/Comment	GPS Latitude/Longitude		Issue No.
	Start	End						Start	End	Photo
1			Pump Stations	Operating Log		U	Item inspected visually only. Item was not operated during the inspection. Inspector Comments: The plant building was not accessible to inspect operating log.	37.431070 ° -121.011730 °	37.431070 ° °	1
2			Pump Stations	Operation & Maintenance Manual		U	Item inspected visually only. Item was not operated during the inspection. Inspector Comments: The plant building was not accessible to inspect O&M manual.	37.431070 ° -121.011730 °	37.431070 ° -121.011730 °	2
3			Structures	Photo Documentation		N	Inspector Comments: Due to lack of response from the maintaining agency this inspection was not able to be completed during the summer 2012 season.	° °	° °	3
4			Pump Stations	Plant Building		A	Item inspected visually only. Item was not operated during the inspection. Inspector Comments: The plant building appeared to be in good structural condition.	° °	° °	4 Y

View of the pumping plant.

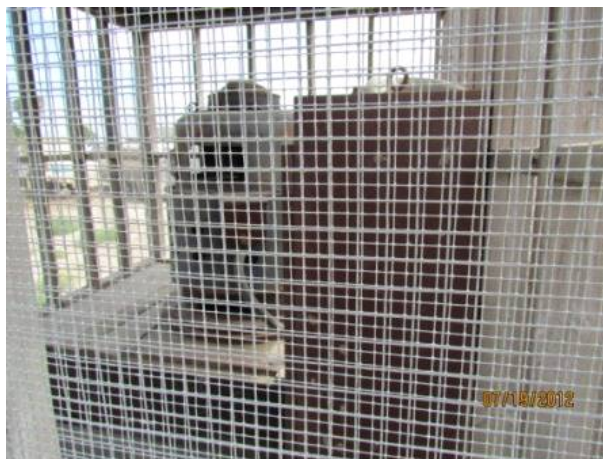
Levee Mile Report Line	7
Start Levee Mile	
End Levee Mile	
Location	
Category	Pump Stations
Item	Pumps

View of the pumps at the plant.

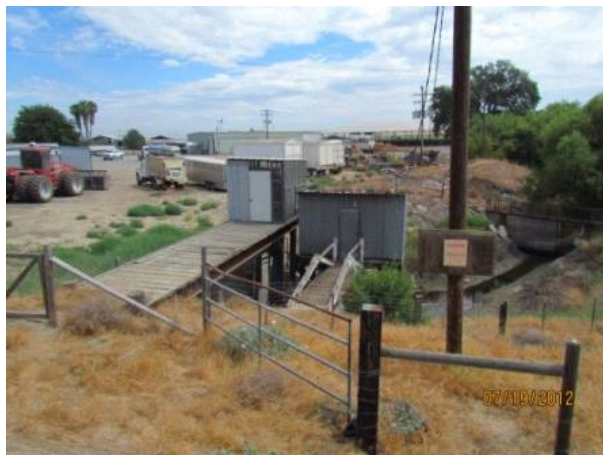
Levee Mile Report Line	9
Start Levee Mile	
End Levee Mile	
Location	
Category	Pump Stations
Item	Power

5			Pump Stations	Cranes		N	Item inspected visually only. Item was not operated during the inspection. Inspector Comments: This item does not exist at this location.	° °	° °	5
6			Pump Stations	Safety		A	Item inspected visually only. Item was not operated during the inspection. Inspector Comments: There was no any significant safety hazard present outside of the pumping plant during inspection.	° °	° °	6
7			Pump Stations	Pumps		U	Item inspected visually only. Item was not operated during the inspection. Inspector Comments: The pumps were not operated during inspection due to inability to enter the pumping plant.	° °	° °	7 Y
8			Pump Stations	Motors, Engines, Fans & Gear Reducers		U	Item inspected visually only. Item was not operated during the inspection. Inspector Comments: The pumping plant was not accessible to inspect motors and pumps.	° °	° °	8
9			Pump Stations	Power		A	Item inspected visually only. Item was not operated during the inspection. Inspector Comments: The power source appeared to be safe and adequate.	° °	° °	9 Y

View of the power sources for the pumping plant.

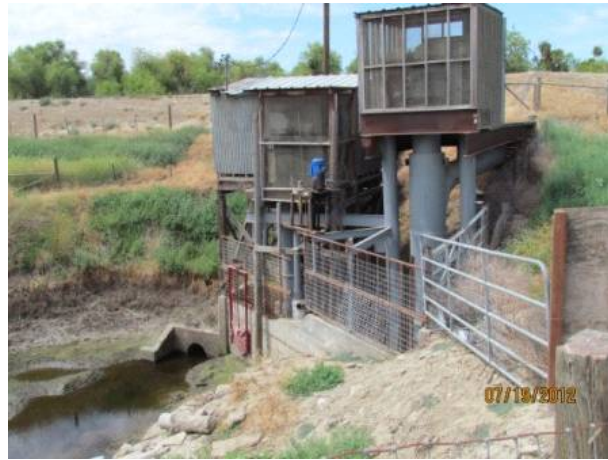
LMR No.	Levee Mile		Category	Item	Location	Rating	Action/Comment	GPS Latitude/Longitude		Issue No.
	Start	End						Start	End	Photo
11			Pump Stations	Sluice / Slide Gates		A	Item inspected visually only. Item was not operated during the inspection. Inspector Comments: The slide gate appeared to be in working condition.	°	°	11 Y
12			Pump Stations	Sumps/Wet Well		A	Item inspected visually only. Item was not operated during the inspection. Inspector Comments: The sump well was free of any debris.	°	°	12 Y
13			Pump Stations	Trash Racks		A	Item inspected visually only. Item was not operated during the inspection. Inspector Comments: The trash racks appear to be fastened in place and in working condition.	°	°	13 Y
14			Pump Stations	Trash Rakes		N	Item inspected visually only. Item was not operated during the inspection. Inspector Comments: Trash rakes were not present at this plant.	°	°	14
15			Pump Stations	Electric Gate Operators		N	Item inspected visually only. Item was not operated during the inspection. Inspector Comments: This item doesn't exist at this plant.	°	°	15

Levee Mile Report Line	11
Start Levee Mile	
End Levee Mile	
Location	
Category	Pump Stations
Item	Sluice / Slide Gates
View of the slide gates at the pumping plant.	
pkazi_t_20120810_158.jpg

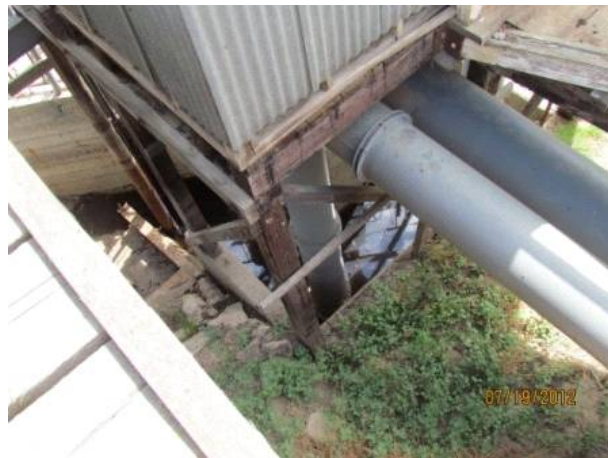
Levee Mile Report Line	12
Start Levee Mile	
End Levee Mile	
Location	
Category	Pump Stations
Item	Sumps/Wet Well
View of the wet well.	
pkazi_t_20120810_159.jpg

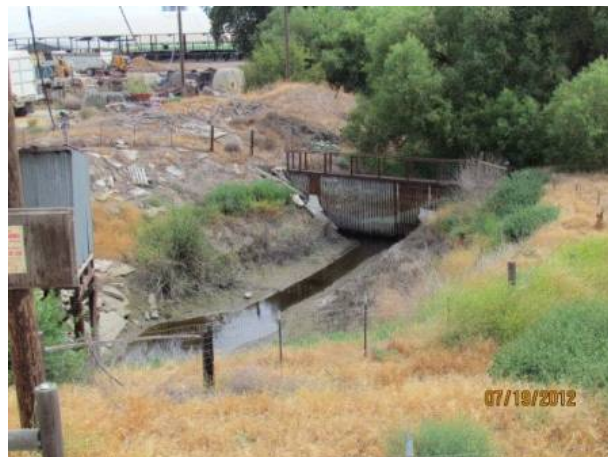
Levee Mile Report Line	13
Start Levee Mile	
End Levee Mile	
Location	
Category	Pump Stations
Item	Trash Racks
View of the trash rack.	
pkazi_t_20120810_160.jpg

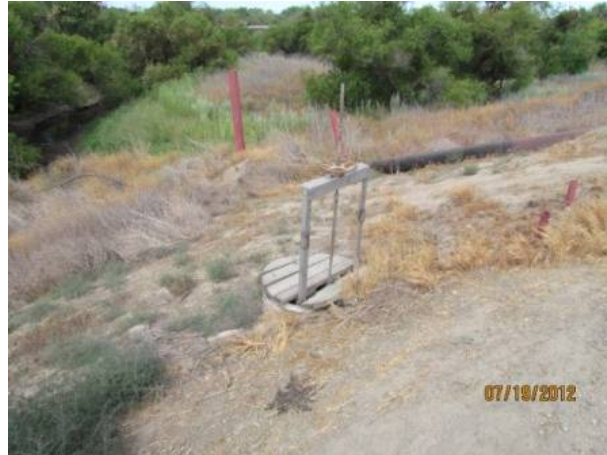
Levee Mile Report Line	17
Start Levee Mile	
End Levee Mile	
Location	
Category	Pump Stations
Item	Manual Gate Operators

16			Pump Stations	Flap Gates		N	Item inspected visually only. Item was not operated during the inspection. Inspector Comments: Flap gate was not visible during inspection.	°	°	16
17			Pump Stations	Manual Gate Operators		A	Item inspected visually only. Item was not operated during the inspection. Inspector Comments: Manual gate operator appears to be in working condition.	°	°	17 Y
18			Pump Stations	Security Fencing		A	Item inspected visually only. Item was not operated during the inspection. Inspector Comments: Security fencing was in good condition and appeared to provide protection against unauthorized access.	°	°	19 Y
19			Pump Stations	Intake and Discharge Pipes		A	Item inspected visually only. Item was not operated during the inspection. Inspector Comments: The intake and discharge pipes appeared to be in good condition.	°	°	20 Y
20			Pump Stations	Communications		U	Item inspected visually only. Item was not operated during the inspection. Inspector Comments: This item was not inspected because the pumping plant was not accessible.	°	°	22

View of the manual gate operator.

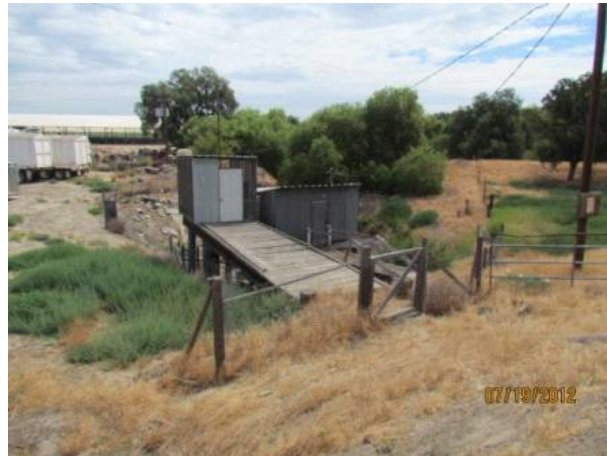
Levee Mile Report Line	18
Start Levee Mile	
End Levee Mile	
Location	
Category	Pump Stations
Item	Security Fencing

View of the security fencing.

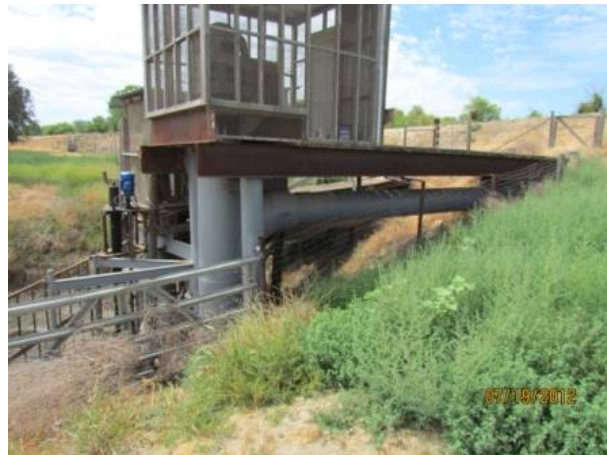
Levee Mile Report Line	19
Start Levee Mile	
End Levee Mile	
Location	
Category	Pump Stations
Item	Intake and Discharge Pipes

View of the pipes at the plant.
